A Nightmare Revisited

The Restoration of the Canadian War Museum's 8.8 cm Flak Gun

Michael H. Miller

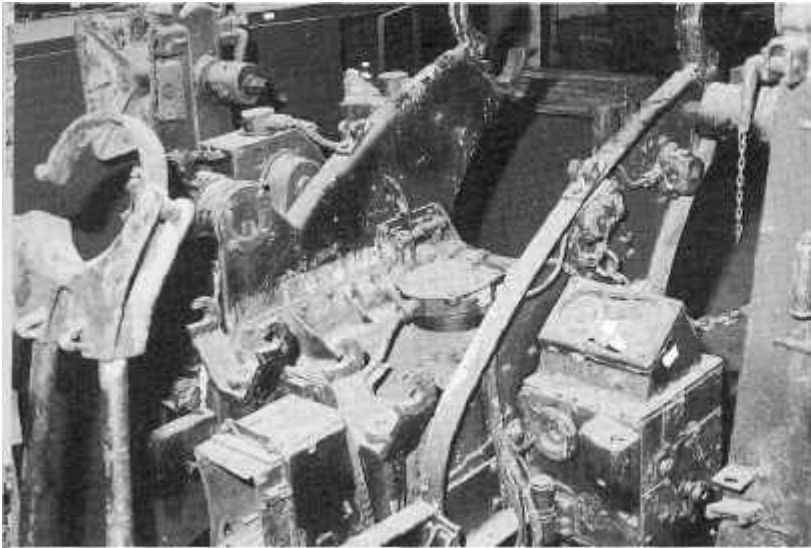
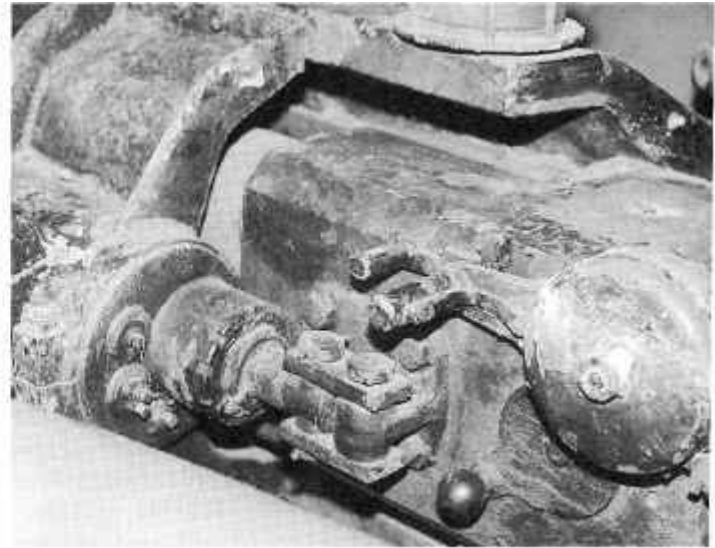
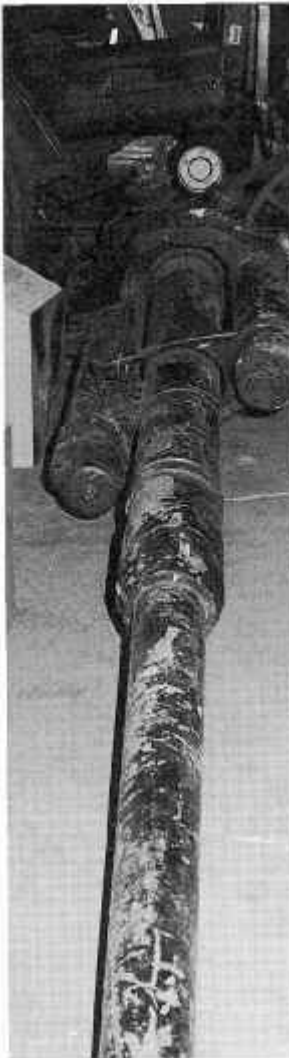
Components of the Canadian War Museum 88 prior to restoration: **Above left:** The pedestal assembly - virtually every moving component was firmly rusted and seized. **Above right:** The breech mechanism of the gun. **Opposite:** The barrel assembly. (Photos courtesy of author)

while extensive corrosion hid many small problems, such as seized bearings and damaged parts. Ironically, the fact that gun was already disassembled into its major parts now saved time. However, the parts were extremely heavy and awkward to manoeuvre, necessitating a forklift to move parts from one work area to another. The combined weight of the barrel and recoil assembly was close to 4,000 pounds, the mount and pedestal assembly 8,500 pounds. Even the two equilibrator springs weighed 400 pounds each.¹³

was firmly rusted in place and, where there was no rust, the original grease had turned into a glue-like substance that was difficult to remove. After many applications of penetrating oil under pressure, the grease and rust began to dissolve. Using an aluminum block and bronze hammers, so as not to mar the original steel, I finally forced the breech block to move. Several more days of applying oil and pressure were necessary before the breech opened fully and could be removed. I then proceeded to disassemble it and return it to working condition.

The pedestal assembly was next. Before work could commence, a large tent of polyethylene had to be constructed around it. This precaution was necessary to contain the dust and residue that would be created by the abrasive stripping procedure. Any components that could be removed from the pedestal assembly were taken to another work area. Other parts and critical areas were covered and protected from abrasive materials and dust. Unfortunately, the folding legs of the pedestal assembly were rusted and seized in the upright position. With enough penetrating oil and downward pressure the legs were eventually lowered.

The next major hurdle to overcome was the elevation mechanism mounted in the pedestal. So many layers of paint had been applied over the years that the drain holes built into the top of the pedestal had been blocked. These blocked drains allowed water to accumulate around the elevation pinion and its bearings. The entire assembly was rusted and seized. Much to my dismay, I discovered that the entire elevation gearing assembly had to be removed in order to gain access to the elevation pinion. Doing so lengthened considerably the total time spent on the project. Once the pinion and bearings could be removed, I discovered that the bearings were not restorable. However, there was a silver lining to this dark cloud. While cleaning the bearings, I found their manufacturing marks. SKF, an industrial firm that still exists, manufactured these pieces. I went to a local bearing store with the faintest of hopes of finding a match, and, unbelievably, the store not only carried the correct size, but the bearings I needed were still manufactured by SKF. They fit perfectly.

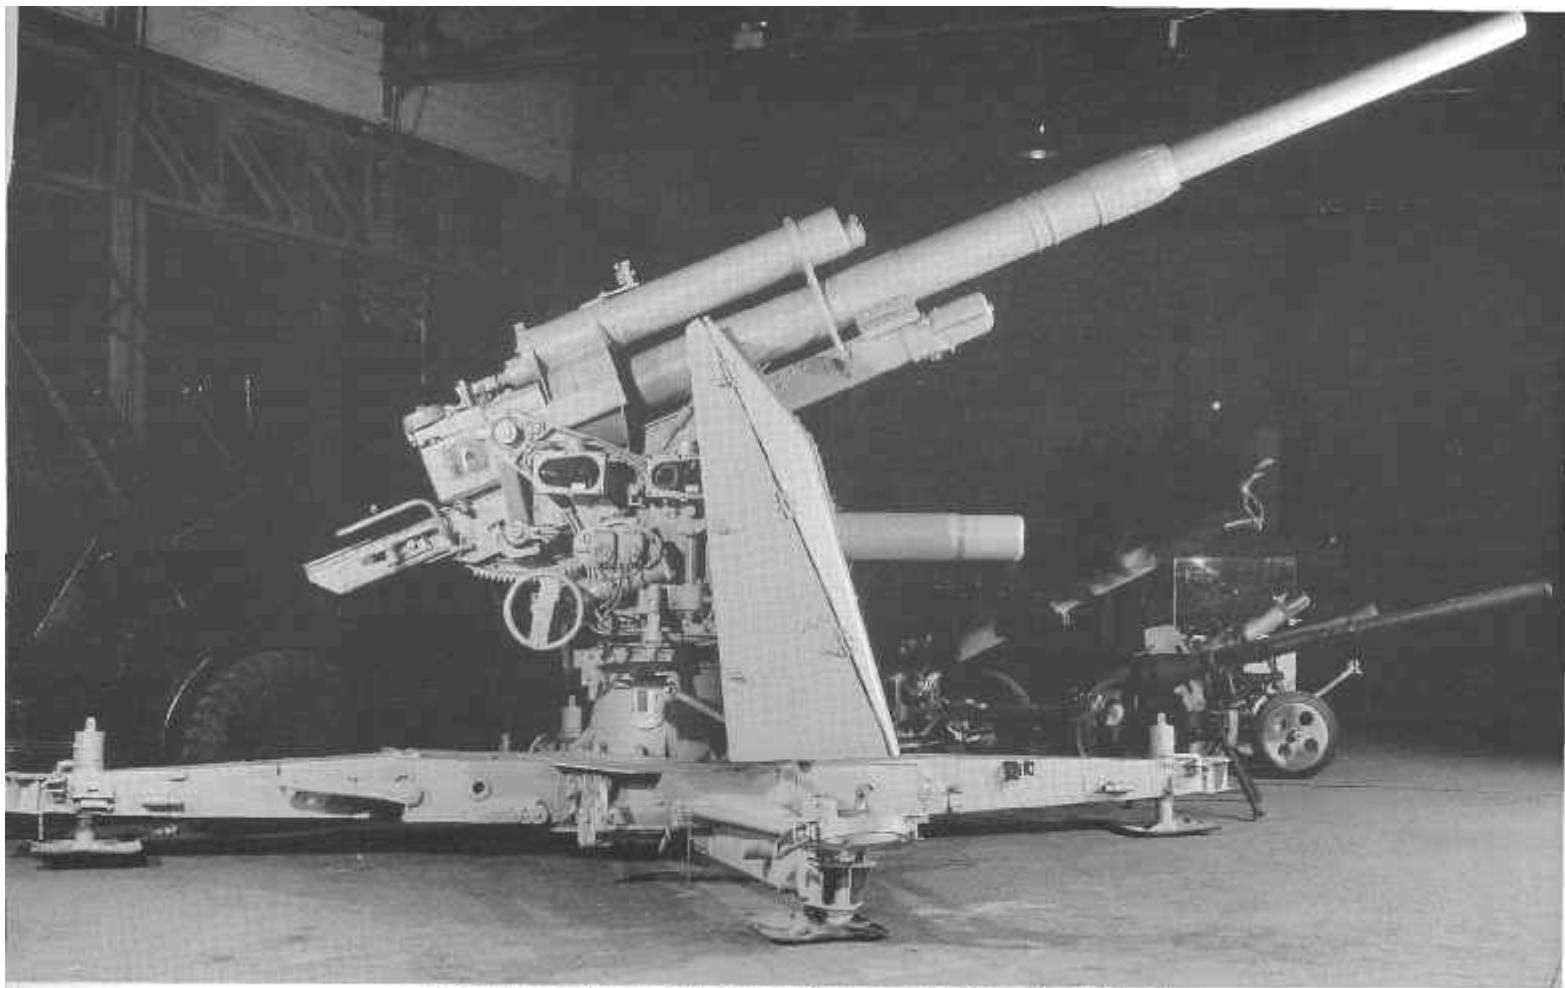
The restored 8.8 cm Flak 37 on display at the Canadian War Museum.

At this point, the major components had been stripped of old paint and corrosion. The gun was now ready for its first coats of new primer and paint. A clean polyethylene tent was constructed in which to do the job. I selected an automotive paint because of its durability and the relative ease of matching the original colour. The most challenging parts of the project were now behind me. The artifact was taking on new life and, for the first time in more than 50 years, the CWM's Flak 37 was looking factory fresh.

The components now had to be reassembled into the completed gun. This job required six technicians and a forklift. The first step was to set the equilibrators back into place. Once in place, the equilibrators had to be secured until they could be connected to the cradle and barrel assembly, which in turn were placed onto the pedestal. The cradle trunnions could not be dropped straight down into the pedestal mount. Instead, they had to be lifted to the proper height and moved into place laterally. After several abortive attempts, the trunnions were finally placed into the mounts, which were then bolted shut. The artifact was now beginning to look like the famous German 88. But much work remained. A gun barrel as heavy as that of the 88 will not elevate without the assistance of the spring equilibrators, but I quickly discovered that the equilibrators could not be connected to the cradle until the barrel was at its maximum elevation of 85 degrees. The end of the barrel was strapped to the forklift, and, while the forks were slowly raised, a technician cranked the elevation handwheel to match the speed.

Before fastening the shield to the pedestal the full function of the traverse and elevation had to be tested. The traverse operated beautifully. In fact, unless the pedestal was perfectly level, the barrel would traverse on its own in the direction the pedestal was leaning. The elevation was not quite as smooth. After so many years of corrosion and lack of use, the equilibrator springs needed several full elevations to function as intended. We then attached the shield. Although heavy and awkward, it was re-attached in only an hour.
